Project:
Bethesda Christian Church

Location:
Sterling Heights, MI

Manufacturer:
IB Roof Systems

System:
Fully Adhered
80 Mil Membrane

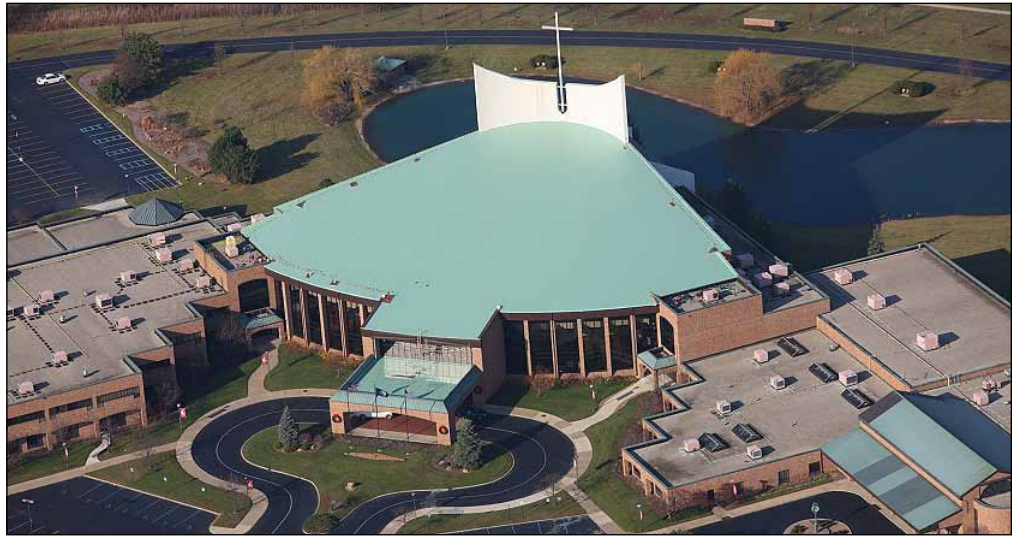
The mushroom-shaped roof measures 211 feet from wall to gutter. Bethesda chose Mike's bid using IB Roof Systems' 80 mil PVC membranes to replace the copper roof. Still, the congregation wanted to maintain the same look and feel, so the membranes were special-ordered to be the same copper color. The appearance so closely replicated the original copper that churchgoers were surprised to learn that it wasn't real copper.

The church has a pitched roof, with a rising incline of 14 feet. As a result, the roofers were forced to roll the membranes uphill. Each piece of PVC was rendered individually so there would be no seams.

After removing the copper roof, Sharpe Inc. added a second layer of 2-inch ISO insulation over the existing plywood. Next they installed 3-inch plates using heavy-duty screws to fasten the insulation. Sharpe Inc. used the FM I-90 pattern for uplift, one fastener per 2 square feet over the entire roof.

Sharpe Inc. installed Bethesda’s new roof using IB’s 80 mil PVC membrane, fully adhered with IB’s water based adhesive, and replaced all the church’s copper copings with 16-ounce copper, each piece manufactured specifically for the project. All of the flashings were installed seamlessly.

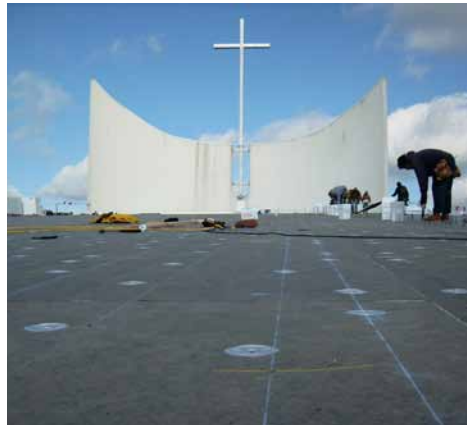
“We chose to put down a protective canopy shield over the roof to keep the rain out,” Mike explains. “It cost nearly \$30,000 to cover it, but it was worth the extra money because it rained the second day on the job.” With the canopy in place, not a single drop of rain got inside the church. “No other contractor thought of it,” Mike says.
